DEPARTMENT OF NATURAL RESOURCES
DIVISION OF OIL, GAS AND MINING

RE: Site Inspection, Geokinetics, Seep Ridge Project, M/047/002, Uintah County, Utah

Date of Inspection: November 14, 2002
Time of Inspection: 8:30 to 11:30 a.m.
Conditions: Cloudy, 30's
Participants: Mickey Schott, Geokinetics; Paul Baker, DOGM

ATTACHMENT
November 18, 2002
Photographs
M/047/002, Seep Ridge Mine, Geokinetics

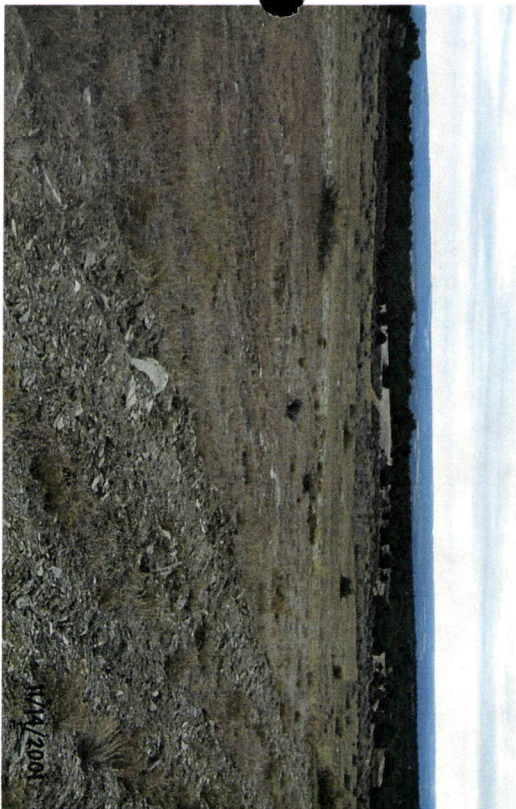
There was a road through the camp area, and this was the only part of this area that was ripped. There are several places dominated by weeds in the camp area that were not ripped or, I presume, seeded (Photo 1).

Photo 1. Camp area with ripped and seeded road on the lower right. Parts of the area have little desirable vegetation and were not ripped and seeded.

Portions of the camp area containing mostly weeds should be ripped and seeded. There was one other area southeast of the entrance that should also be ripped and seeded.

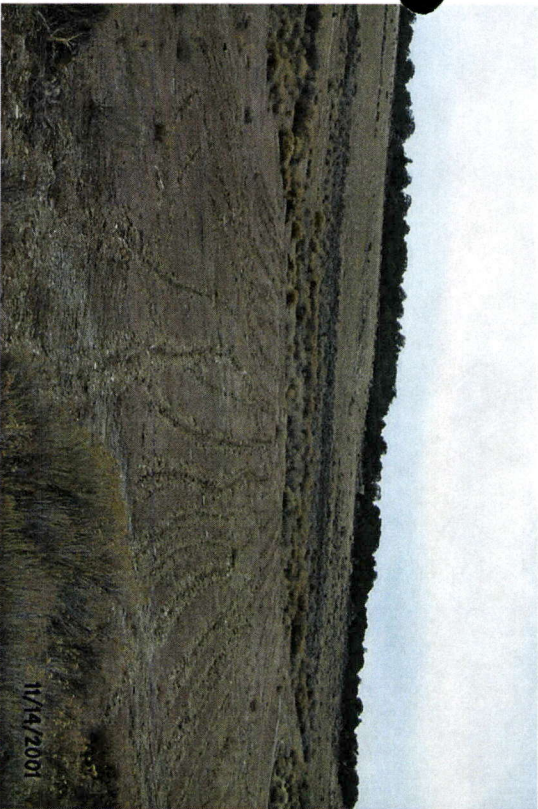
Photo 2 shows the area southeast of where the shop building stood. This area was ripped and seeded. I did not measure or pace the distance between rips, but, as I recall and based on the photos, it varied from about four feet to less than one foot.

Photo 2. Area southeast of where the shop building was.

The operator may want to rip and seed the area southeast of the shop pad a little better, but I decided to leave this to their judgment. I anticipate that seeded grasses will grow in the rip marks, but I do not expect much growth outside these marks.

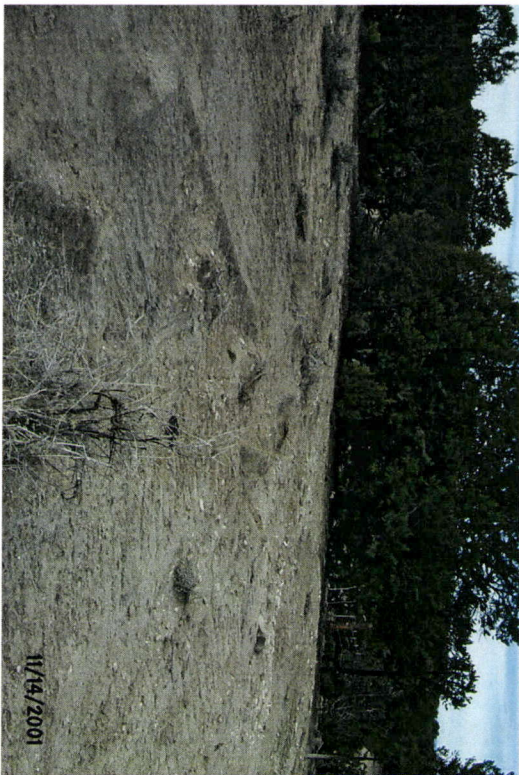
We went to the all of the monitoring well sites. These sites and the access roads have been ripped and seeded, and there was no surface evidence of the wells. I took photos of all of these sites but have only included one (Photo 3) in this report.

Photo 3. One of the water monitoring well sites.

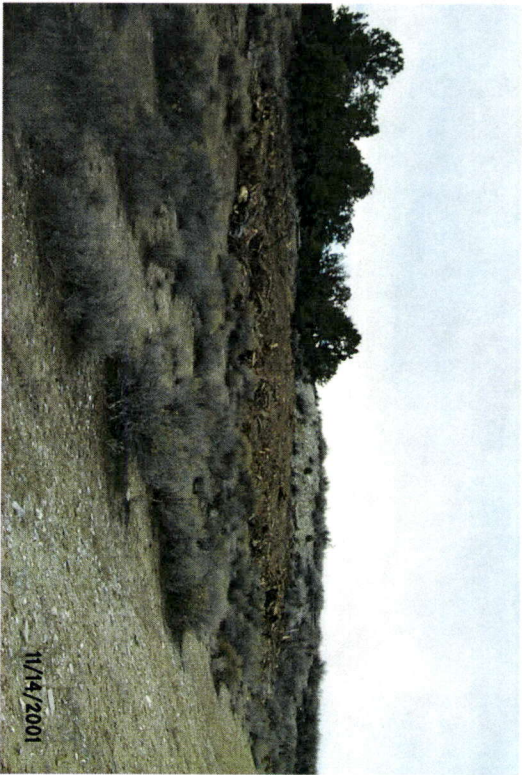
The report for the August 21, 2002, inspection mentions three brush piles that were to be spread around. I only remember seeing two, and during this inspection we only found two. Although I had expected these piles to be spread over large areas, they were, instead, spread around the immediate areas where these piles had been (Photo 4).

Although the brush piles were not spread like I expected them to be, I have no problem with the way it was done. It may take a few years before there is much growth in some of these areas, but because the soil will have so much organic matter, I expect production to be very good once plants start to come back.

Photo 4. One of the brush piles.
